Truss Project - Final Design Report
GEEN 2581 - Fall 2021

Designers: David Hetherington, River Freeburg, Jack Foster, and Sydney Zimmerman

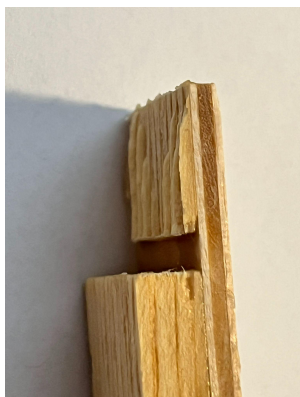
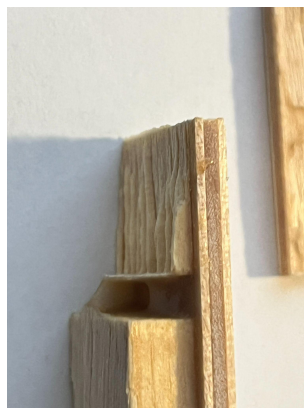
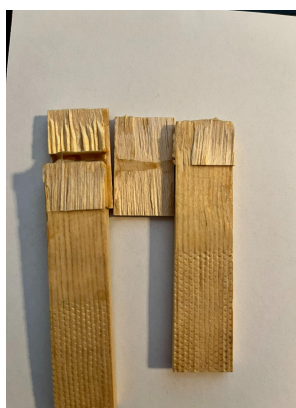
Figure 5: Shear test 1

Figure 6: Shear test 2

Figure 7: Shear test 1

Figure 8: Shear test 2

The shear test was used to determine the strength of the Titebond III Wood Glue. The shear force was recorded as two pieces of pine wood held together by birch plates glued to them were slowly pulled apart. The first test (Figure 6 and 8) failed at a force of 949.77 lbs and the second test (Figure 7 and 9) failed at a force of 1119.94 lbs. The shear stress for the first specimen was 1252.5 psi and the second was 1544.4 psi. The glue in test 2 was stronger than our second test. Both specimens broke the same way with one plate breaking off completely along with taking some of the pine wood with it while the other plate remained attached to one piece of pine. Table 2 shows the results of the test and Graph 3 and Graph 4 show the time versus load curve.

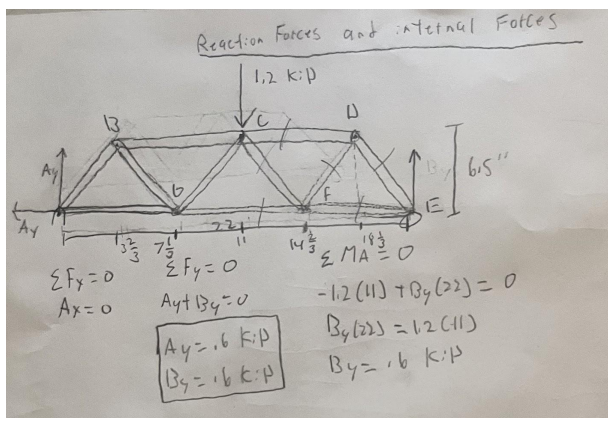
Figure 14 - Reaction forces

The truss will be tested by a downward force applied to the central joint. Two rollers will hold the truss at the bottom 22 inches apart (Figure 12). The truss is intended to support 1.2 kip so each roller will have an upward reaction of 6 kip (Table 4). The support reactions will be calculated by creating a free body diagram, then calculating the forces in each direction (Figure 12).

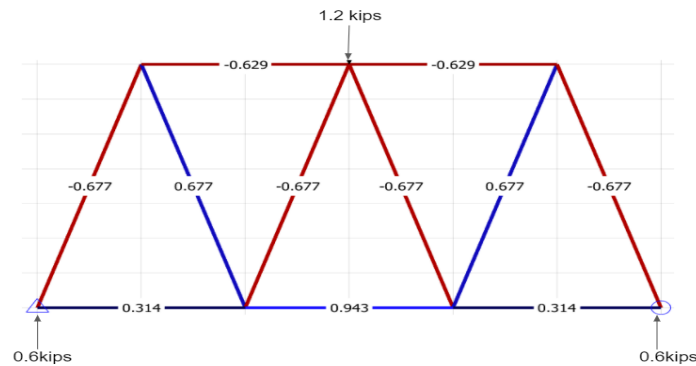
Figure 15 - MATLAB drawing

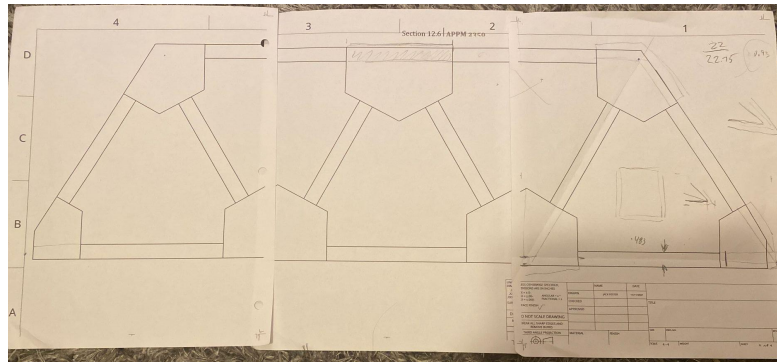
Figure 19 - CAD printout

The first step in our fabrication process was to print out a to scale CAD drawing of the truss we designed. We printed it across 3 pieces of paper (Figure 17) and then measured important members with calipers to confirm our print out measurements were correct.

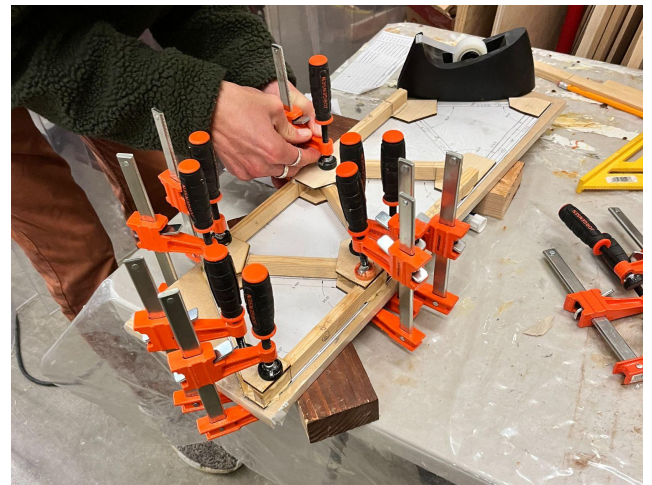
Figure 21 - clamping members

After all of our components were cut, we taped down our drawing onto a wooden board then covered it with a thin layer of plastic. This step is necessary to ensure that our gusset plates and members get glued down in the correct spot. We started with gluing down the gusset plates onto the plastic sheet using a glue stick (Figure 18). This sets a good foundation for our members to get attached to. Then, one by one we placed each member in its corresponding position to be glued and clamped (Figure 19).

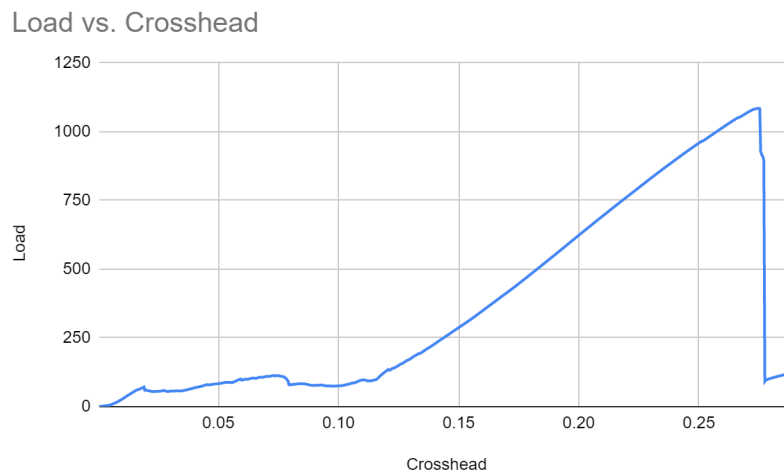
Figure 23 - Lb/Inch Deflection Graph

The load was applied to the truss until it reached failure at 1084.8 lb, where the truss broke on the far right bottom gusset plate (Figure 23). The load vs deflection increased in a mostly linear manner with some peaks in the beginning (Figure 21). These peaks were due to small adjustments with the beams settling into the glue and the truss settling onto the rollers as more force was applied. The truss failed due to shear stress on the gusset plate at E (Figure 23).
